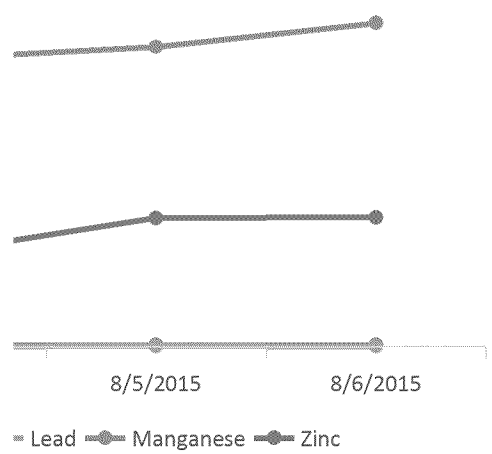
on: A68

Location ID	Date Sampled	Cadmium	Copper	Lead	Manganese	Zinc
A68	8/5/2015	0.828	3.45	0.232	737	199
A68	8/5/2015	0.815	3.16	0.283	727	238
A68	8/5/2015	0.974	3.52	0.82	757	324
A68	8/6/2015	0.85	3.26	0.329	817	326

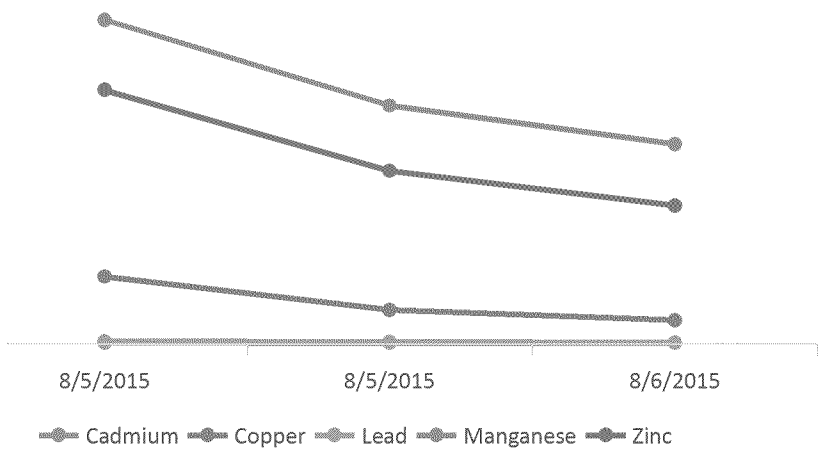
Location: CC48

ocation ID	e Sampled	Cadmium	Copper	Lead	Manganes	Zinc
CC48	8/5/2015	30.6	2260	73.9	10900	8540
CC48	8/5/2015	19.1	1130	54.1	8020	5820
CC48	8/6/2015	14.2	786	30	6720	4650
